The restoration of San Francisco (St. Frusquin), Reserve, Louisiana

BY HENRY W. KROTZER JR.

IN 1973 THE Energy Corporation of Louisiana, Limited (ECOL) purchased San Francisco (once called St. Frusquin) plantation in Reserve, Louisiana, as the site for an oil refinery. At the instigation and insistence of Frederick B. Ingram, a New Orleans businessman and philanthropist, the decision was made to preserve the plantation house (Pl. I), a conspicuous Victorian building on the east bank of the Mississippi River about an hour's drive upriver from New Orleans. Late in the year the architectural firm of Koch and Wilson, of which I am a partner, was retained to handle the restoration of the house. In 1974 the National Park Service declared the house a National Historic Landmark, and by late 1975 the ownership of the house and site had been turned over to a private foundation funded by ECOL and associated companies. In the autumn of 1976 Marathon Oil Company purchased the refinery from ECOL, and has continued funding the restoration through the foundation. The building will soon be opened to the public.

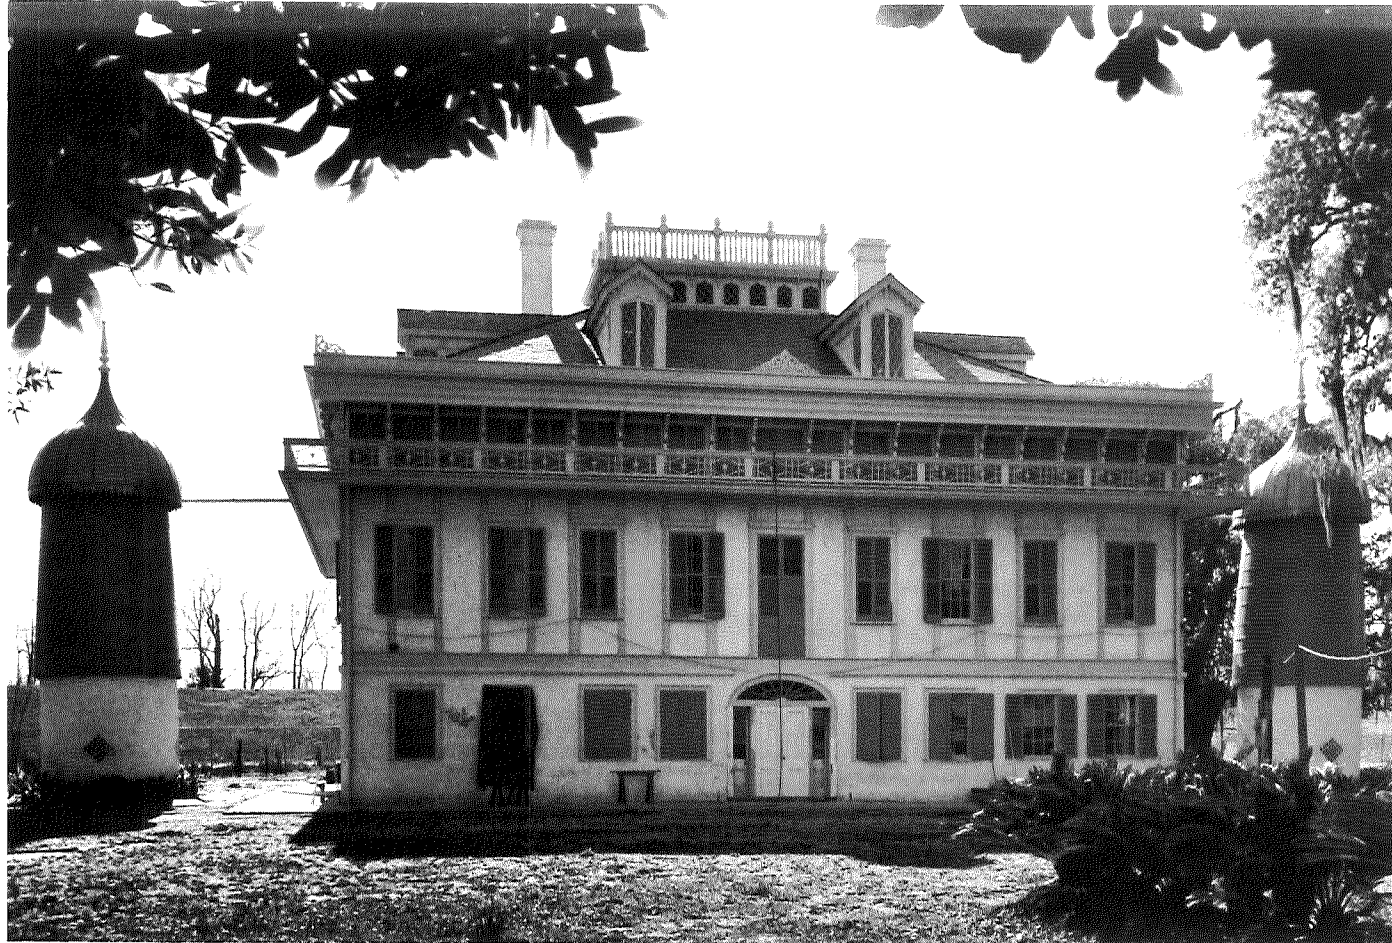
Fig. 3. San Francisco from the back during restoration. Photograph by Frank Lotz Miller.

By early 1975 the paint analysis was under way, the archaeologists were at work on the site, and we were able to start opening up the building and removing later work. We began by looking at some obvious problems, starting with the center back room on the main, or second, floor. In old Creole practice this would have been an open loggia with a small room at each end. But we found that the exterior wall was original. It is a four-inch-thick, brick-between-post wall, stuccoed outside and plastered inside. The posts are exposed on the outside and an applied molding covers the joint between wood and stucco (see Fig. 3).

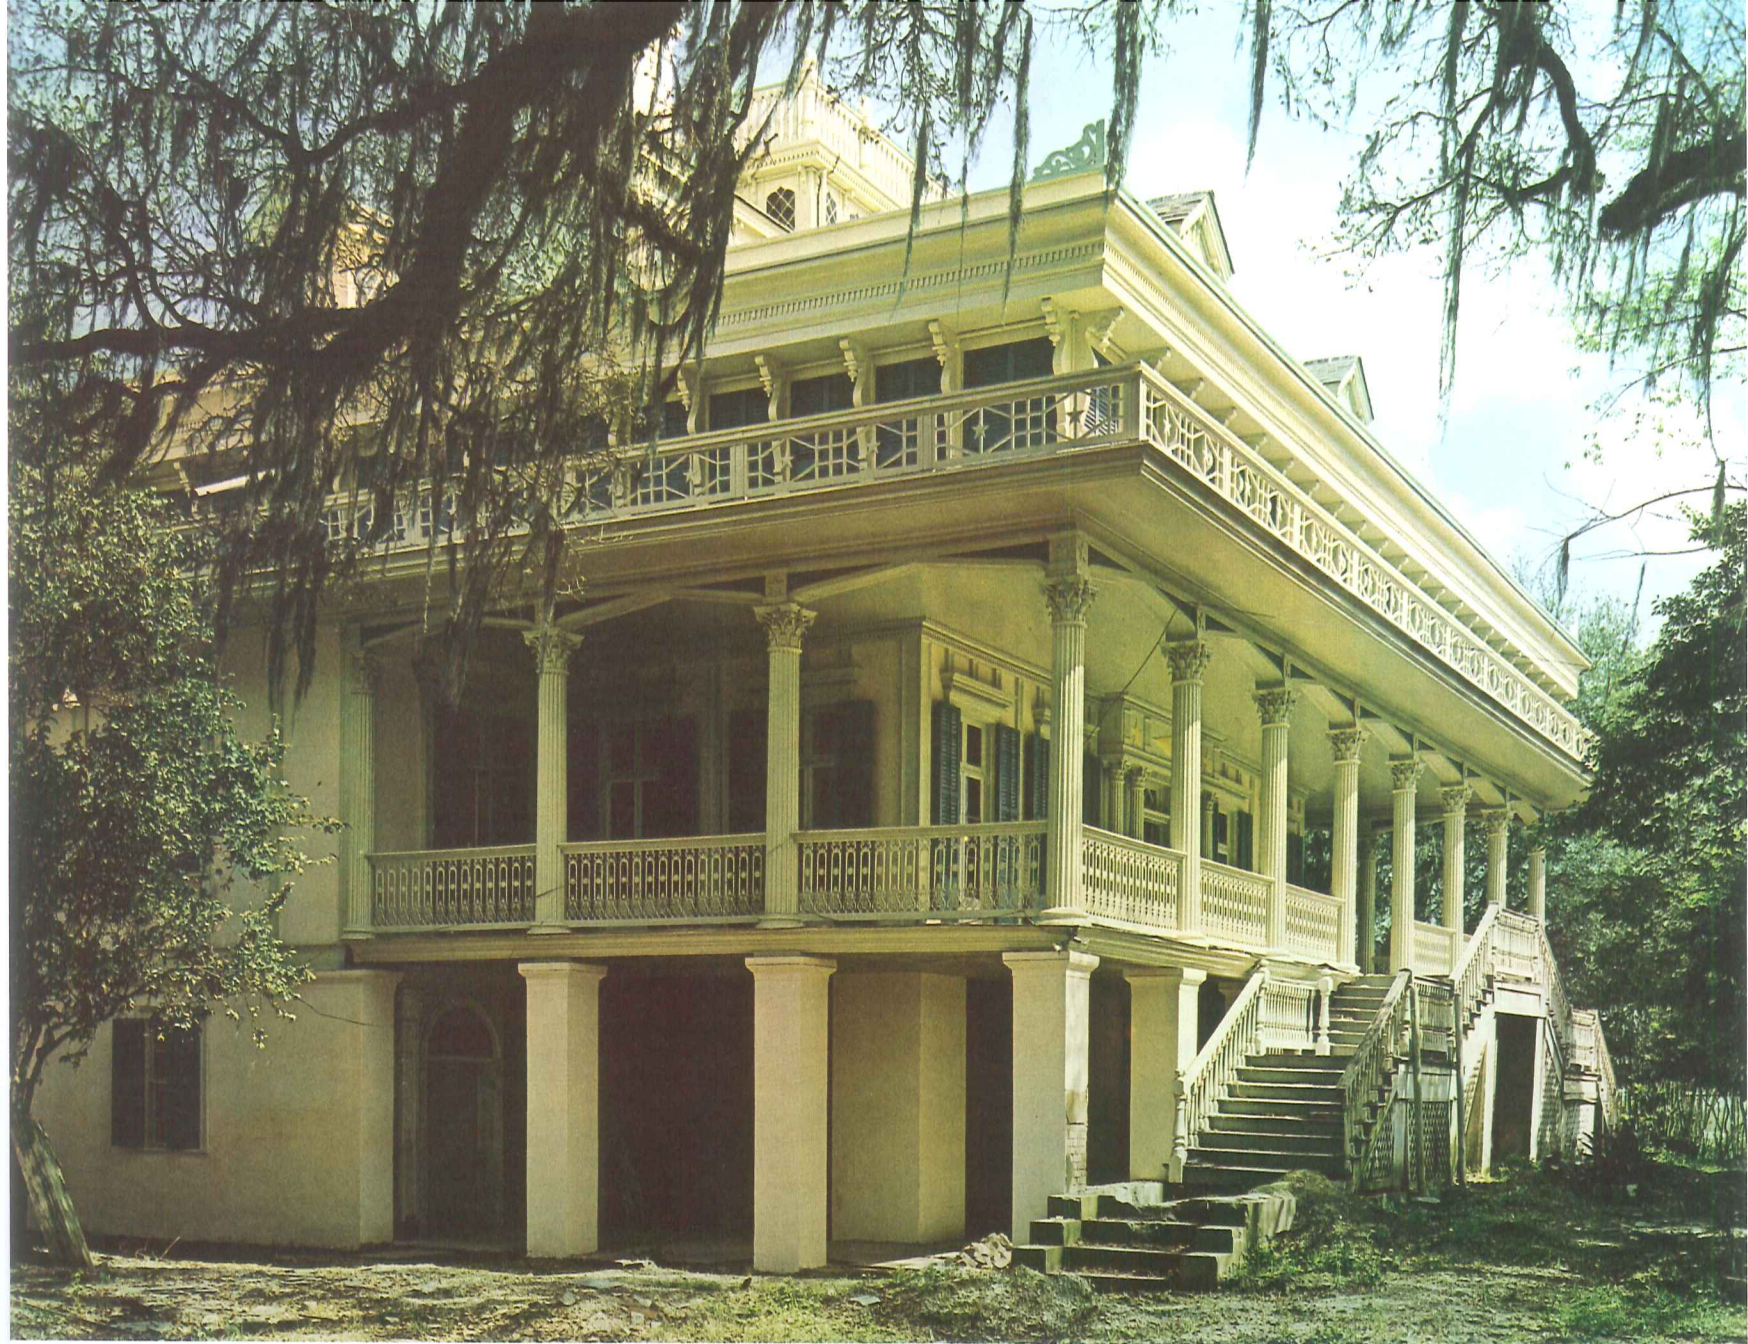
Pl. I. Front façade of San Francisco, Reserve, Louisiana, built by Edmond Bozonier Marmillion (1803-1856), 1853-1856. The front steps have since been restored. The extraordinary color scheme dates from about 1854. *Except as noted, photographs are by Helga Photo Studio.*

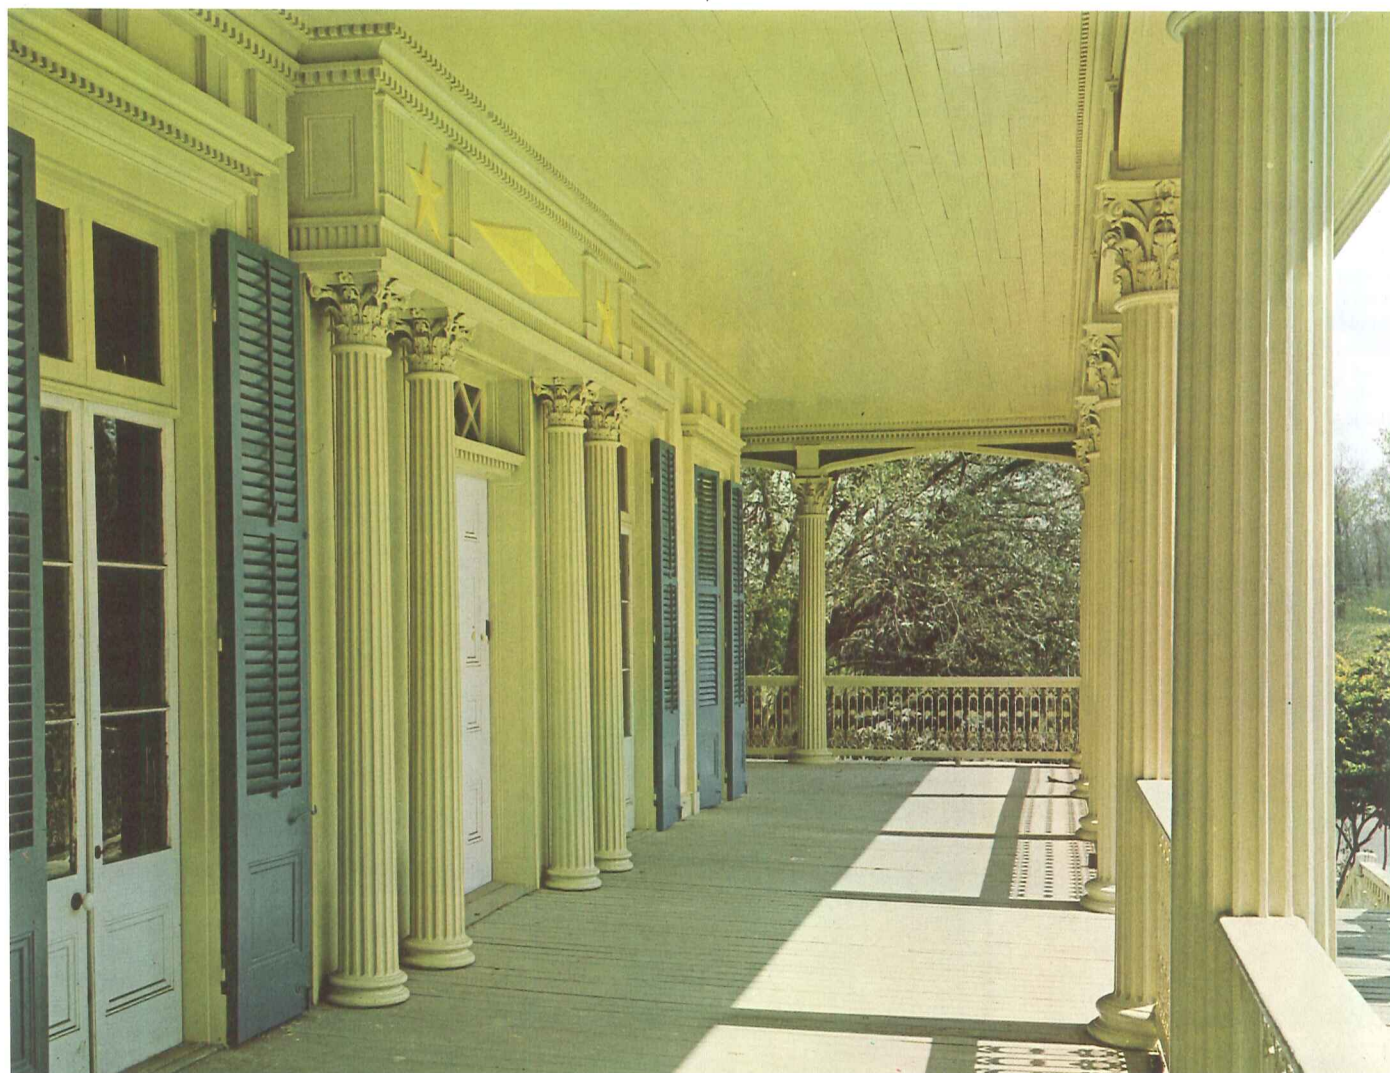
Pl. II. Front gallery. Restoration is complete except for oak graining the front door.

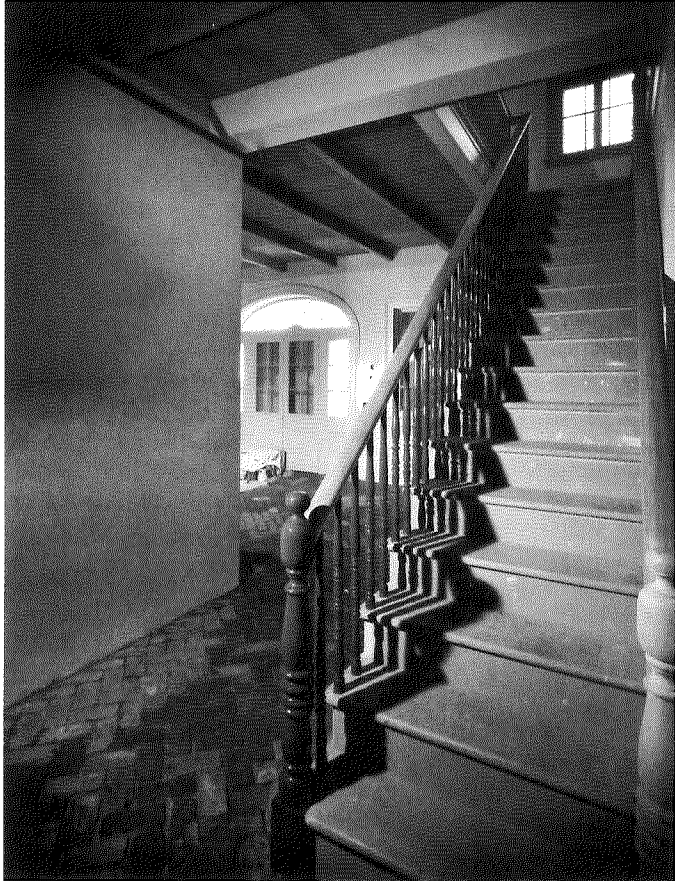
Fig. 5. Ground floor restored, showing the Creole construction: stuccoed brick walls, brick floors, and the ceiling of exposed dressed joist and floor boards. The sprinkler pipes are visible at ceiling level. The exterior colors are carried through most of the ground floor. *Miller photograph.*

Later wooden ceilings were removed on the ground floor to reveal the original old Creole-style exposed-joint and floor-board construction and significant runs of handmade lead plumbing pipes, all bearing the earliest paint sequences (see Fig. 5). Some of the original herringbone-pattern brick paving remained, and our investigations showed that the ground-floor room now called the dining room originally had a painted and waxed plaster floor.

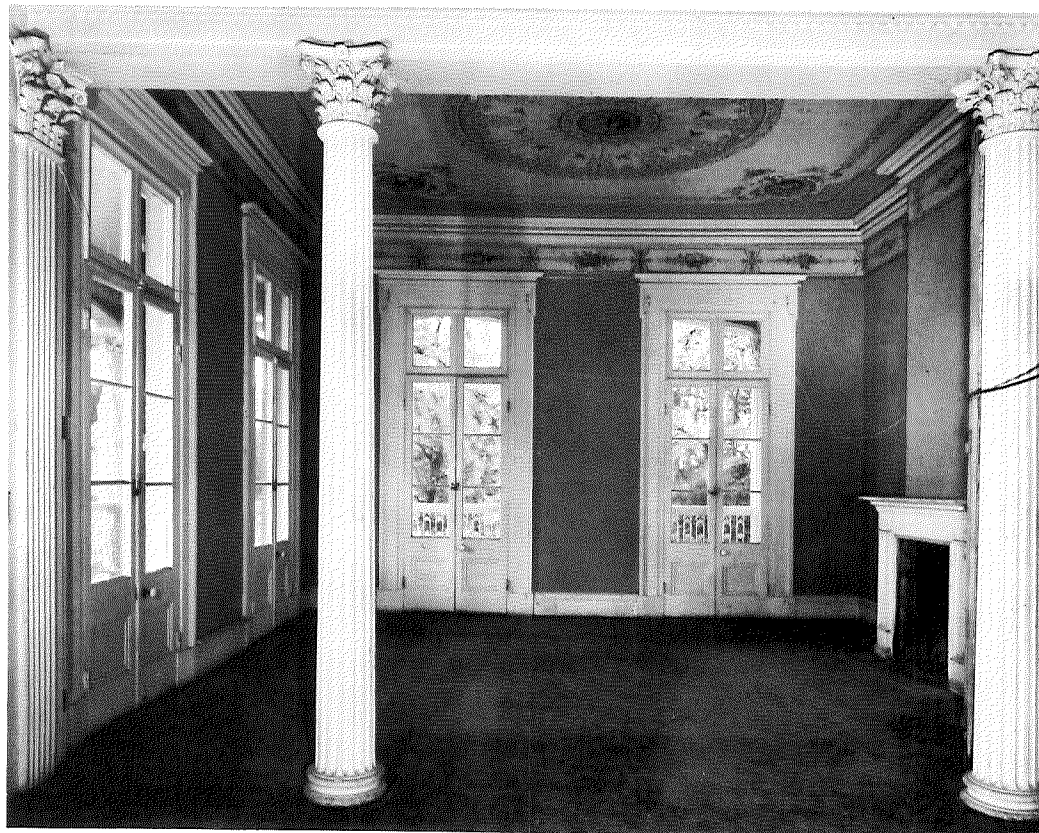
Fig. 6. Parlor at the left of the entry hall before restoration (see also Pl. III, Fig. 7). The typical Creole mantel and French doors were old fashioned by the time the house was built. The capitals of the columns are cast iron and are marked J. L. JACKSON./NEW-YORK.

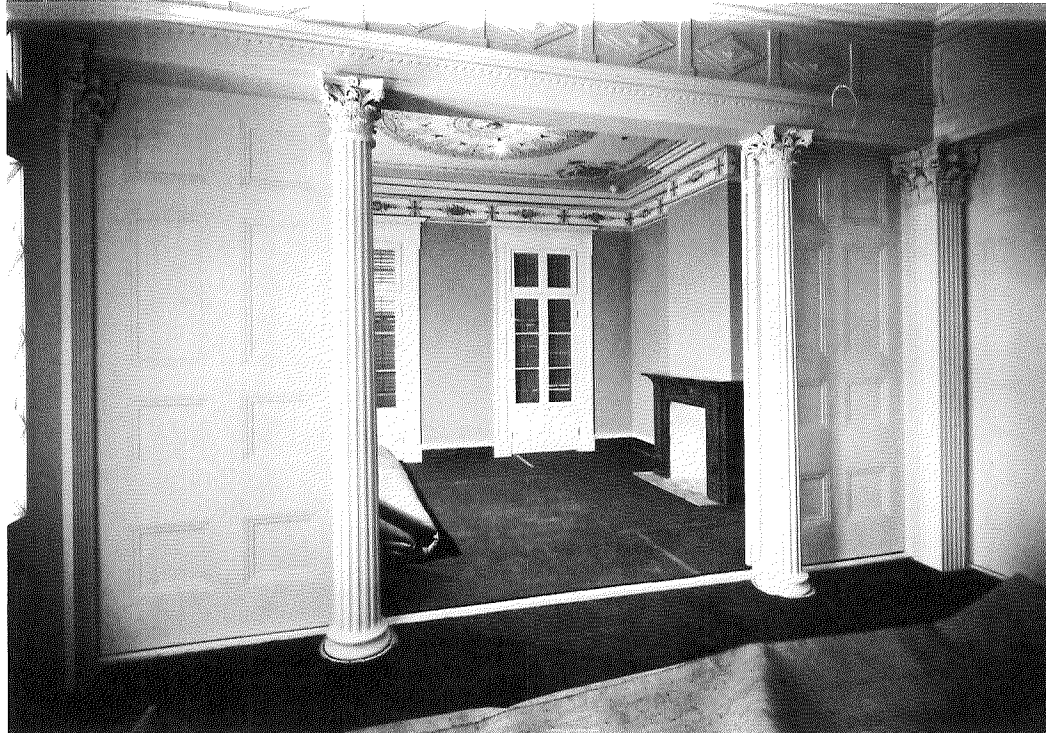
Fig. 7. Main-floor entry hall looking toward the parlor shown in Fig. 6. The original fixed panels have been replaced behind the columns, and the parlor ceiling and marbling of the mantel and baseboards have been restored. Miller photograph.

level, and later one of the stairs had been removed entirely. On two sides of the main-floor entry hall the doors and their flanking fixed panels had been removed (see Fig. 7).

When the exterior had been restored, work on the interior began. Based on evidence in the house, we were sure that the large doors and fixed panels of the main-floor entry hall were original, and we restored them. The missing second interior stair was easily duplicated from the one still in place. On the ground floor the brick floors were relaid, the walls restuccoed, and missing millwork restored—all based on clear evidence in the fabric of the building.

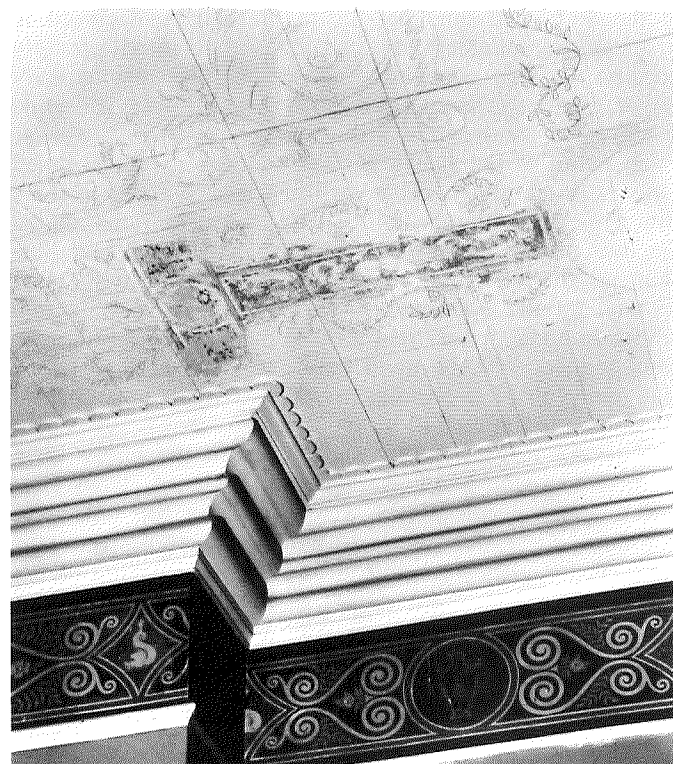
Fig. 8. Detail of the parlor to the right of the entry. The designs of the decorated ceiling have been drawn on the overpainting for later restoration. (The ceiling has since been restored.) The cornices in the house are unusual. In some of the back rooms they are grained to resemble fiddleback maple on the convex moldings and bird's-eye maple on the concave moldings. The effect is remarkably three dimensional.

it in. Drawings of the designs were made directly on the ceilings (Fig. 8), which were photographed, and the basic colors were identified.

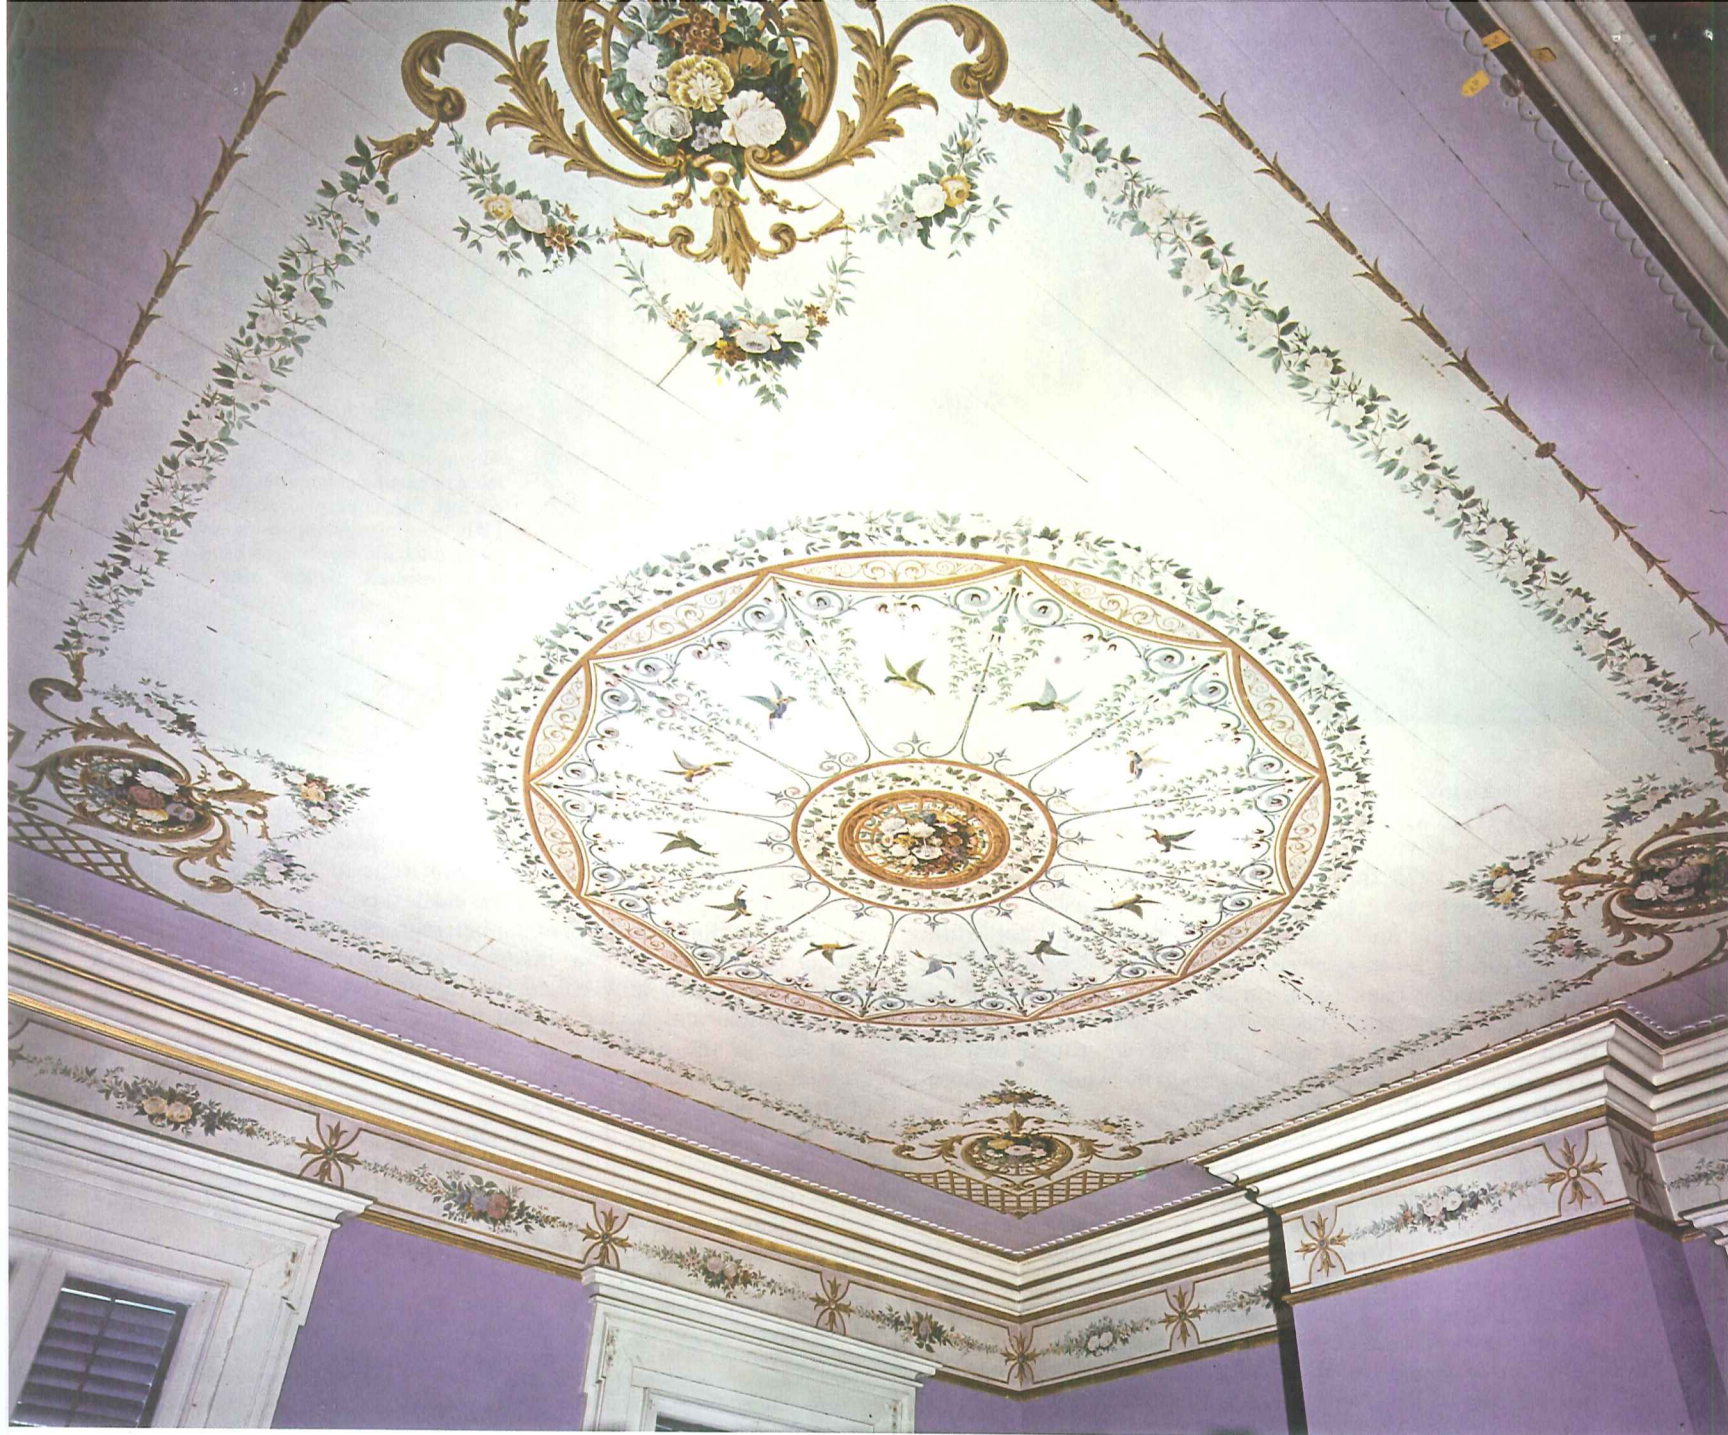
Pl. III. Ceiling of the parlor at the left of the entry hall before restoration (see also Fig. 6).

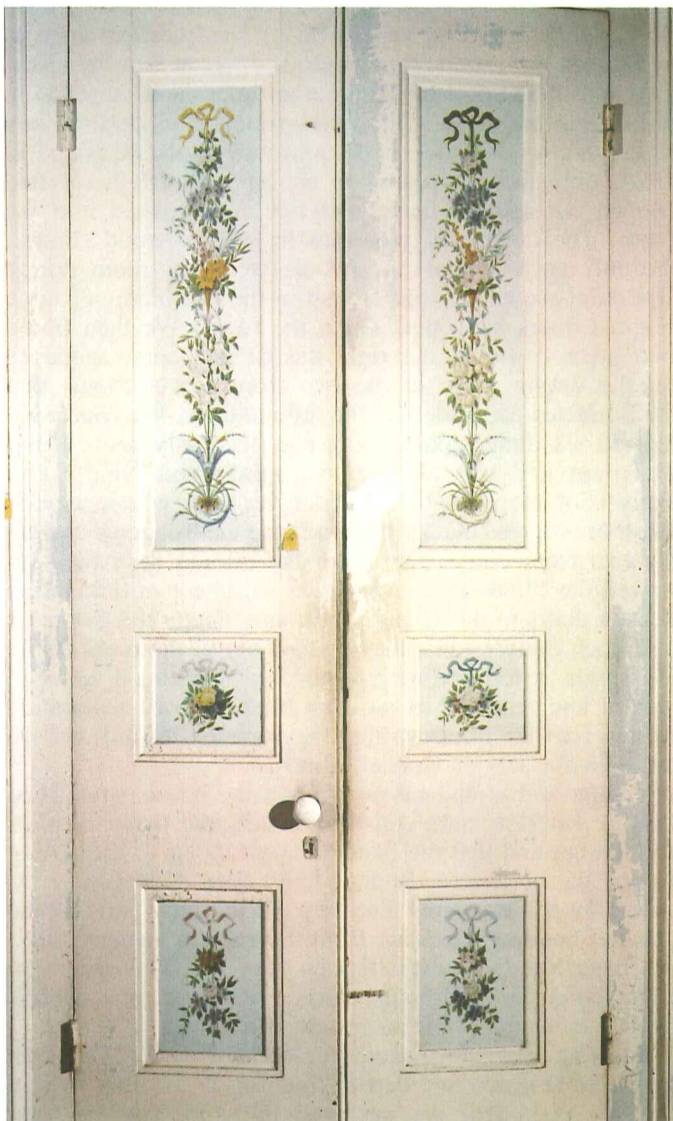
Pl. IV. *Left and below:* Bedroom door and detail showing its lower right-hand panel. The rails and stiles were originally light blue and the trim was picked out with blue lines. The ceiling of this bedroom is painted with a vine-hung lattice and three Negro *putti* in a roundel in the center. *Above:* A panel from one of the right-hand parlor's doors.

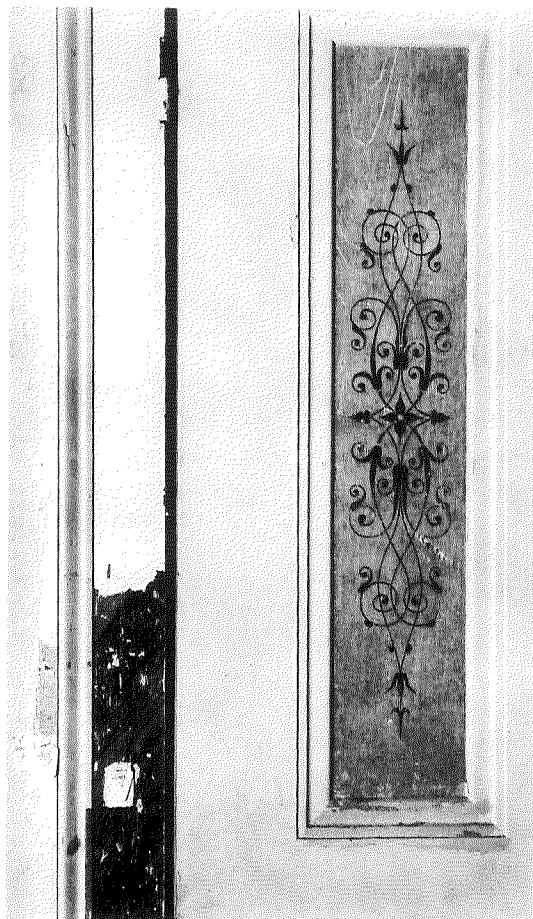
Fig. 9. Detail of a bedroom door. Scraping revealed the grained door-frame and decorated panels. In this room the overpainting could be scraped off fairly easily and most of the original painted decoration had only to be touched up.

Extensive paint scraping was done on the interior to reveal as much of the original graining and marbling as possible. In two rooms the paint on the doors and windows and their frames, the baseboards, and a mantel is almost entirely original. A patch of nearly every kind of graining or marbling throughout the house has been kept as a record next to restored areas. The decorated ceilings have been cleaned, touched up, or repainted much as an oil painting is restored.

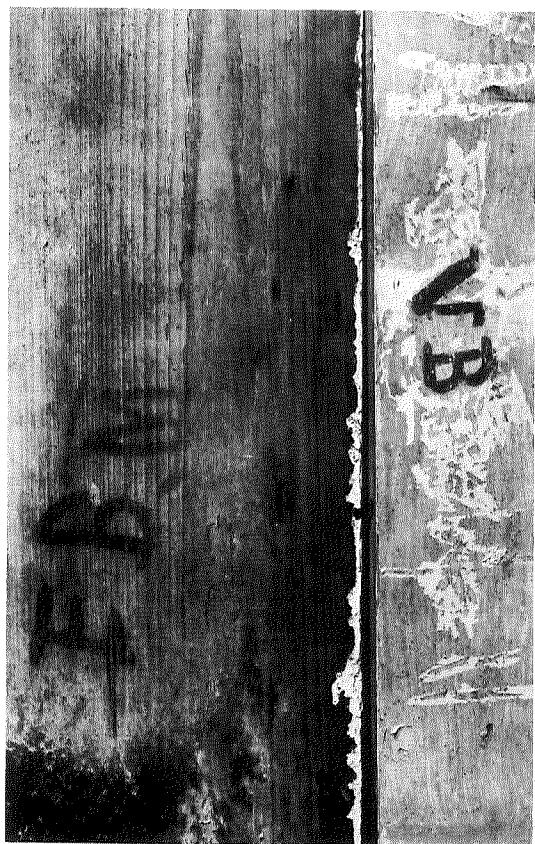
Fig. 10. Much of the millwork in the house bears the painted initials *EBM* for Edmond Bozonier Marmillion. The board bearing the initials *VB* (presumably for Val-sin Bozonier [Marmil-lion]) was found inside a ground-floor closet at the base of one of the chim-neys. As the closet opens to the outdoors, we sus-pect that it was a store-room for boots and other outdoor gear.

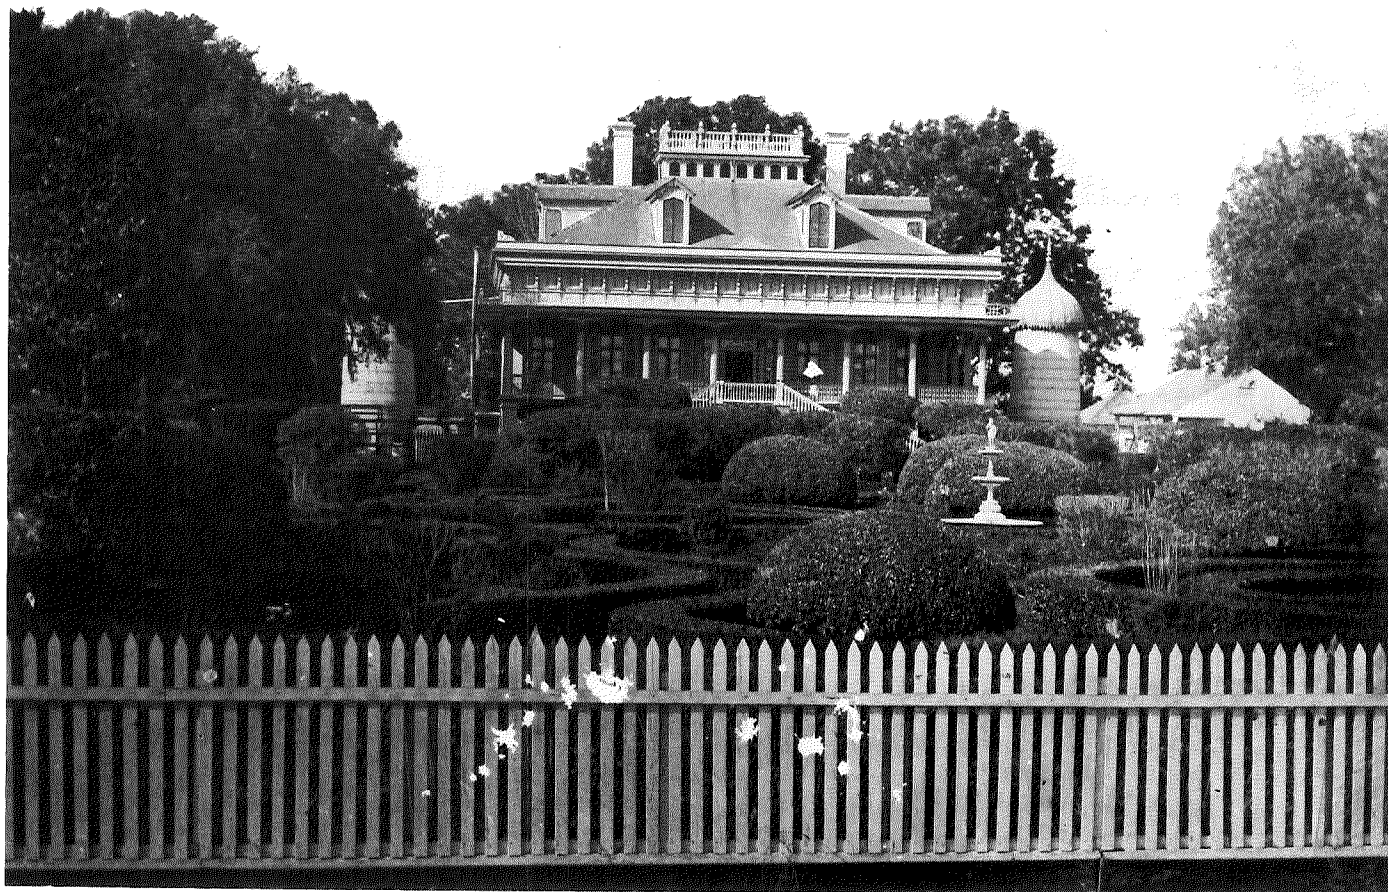
Fig. 11. San Francisco in a photograph taken between 1879 (when the Bougères bought the plantation) and 1896. In 1876 the riverbank at average low water was seven hundred feet from the house; by 1896 it was only three hundred and eighty feet away, and subsequently it moved closer still. Photograph by courtesy of L. N. Bougère.

A photograph taken before 1896 shows an extraordinary formal garden in front of the house (Fig. 11). Had not the levee twice been moved back so that it is now almost at the house, the restoration of the garden would undoubtedly have been recommended.
